Determination of thermal shock resistance degree LEDs ON @ 1A - Temperature set in the climatic chamber 40°C

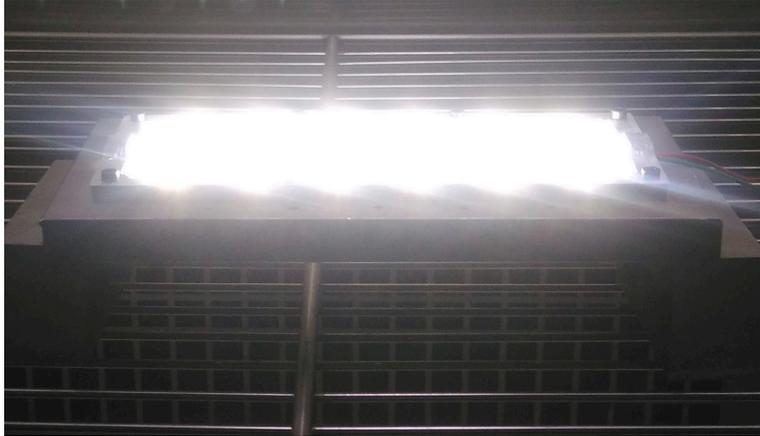
The part resulted physically intact.

Photo: the part in the climatic chamber.

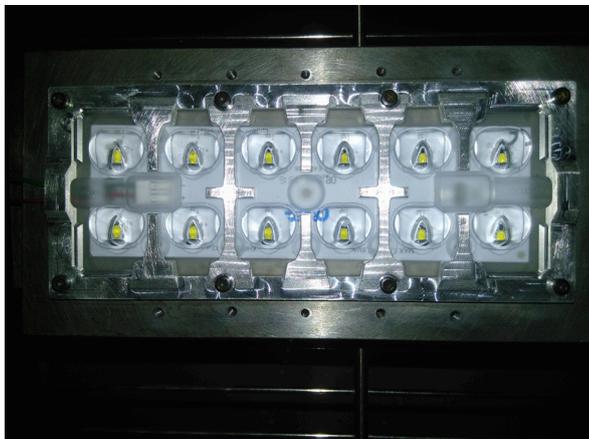
After testing, a final visual inspection was performed. The result was positive. (view photo)

Photo: the part in the climatic chamber after testing.

Based on the testing results, no physical deterioration of the material occurred.
